PHASE I INSPECTION REPORT  
NATIONAL DAM SAFETY PROGRAM

**CATARACT CREEK DAM  
PONY, MONTANA  
MADISON COUNTY  
MT-5**

PREPARED BY:  
CH2M HILL  
BELLEVUE, WASHINGTON

APRIL 1980

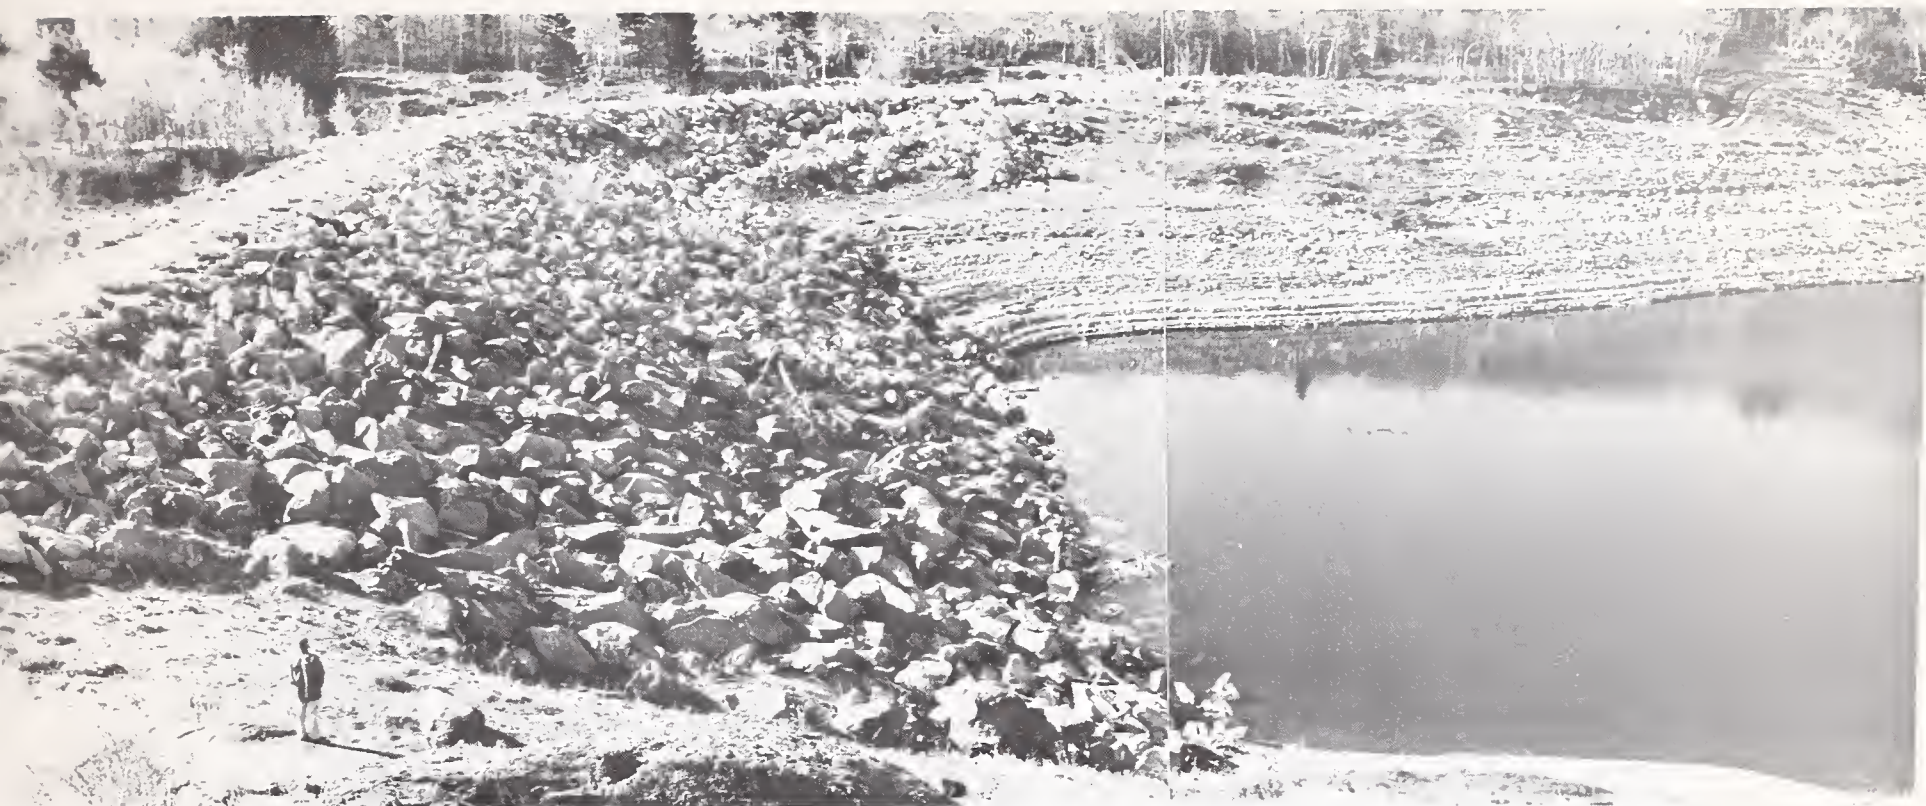
The upstream embankment slope is adequately protected from erosion caused from wave attack by a layer of large riprap (see Photos 1 and 2). The height of wind-generated waves is limited by the short fetch and is estimated to be less than 2 feet.

PHOTO 1      Cataract Dam upstream slope and right abutment. Spillway approach channel at upper right corner. Note large size riprap.

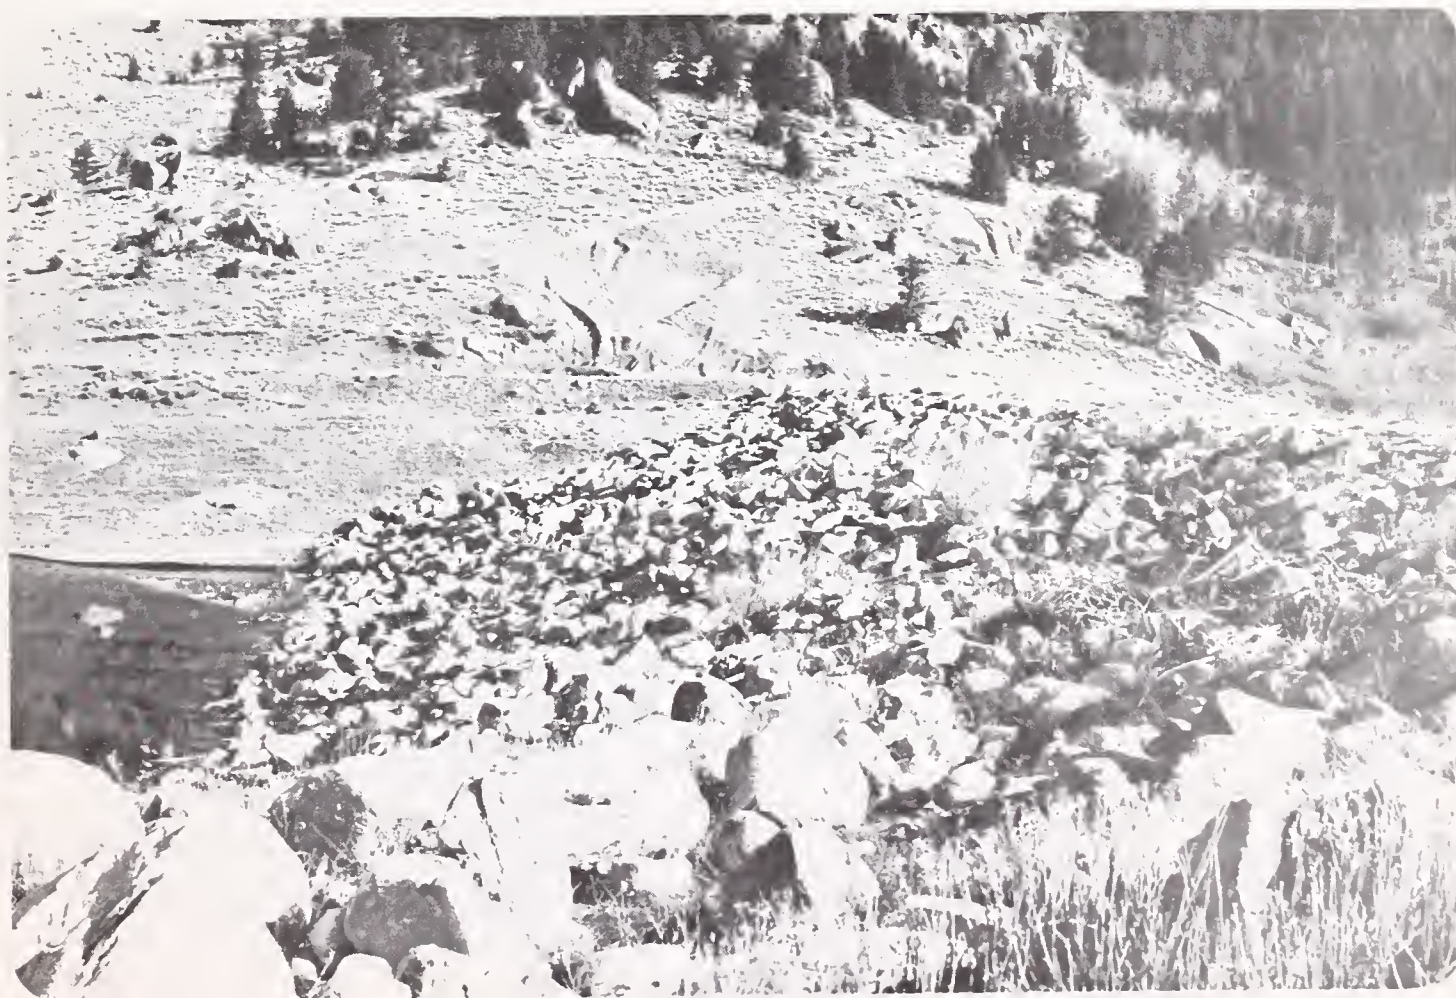
Cataract Dam is founded on both glacial sediments and granitic bedrock. The left abutment consists of massive, relatively impervious granitic rock (see Photos 2 and 3), and the right abutment consists of a recessional moraine composed of silty sand, sand, gravels, and boulders (see Photo 8).

PHOTO 2      View towards left abutment and impervious borrow above dam crest.

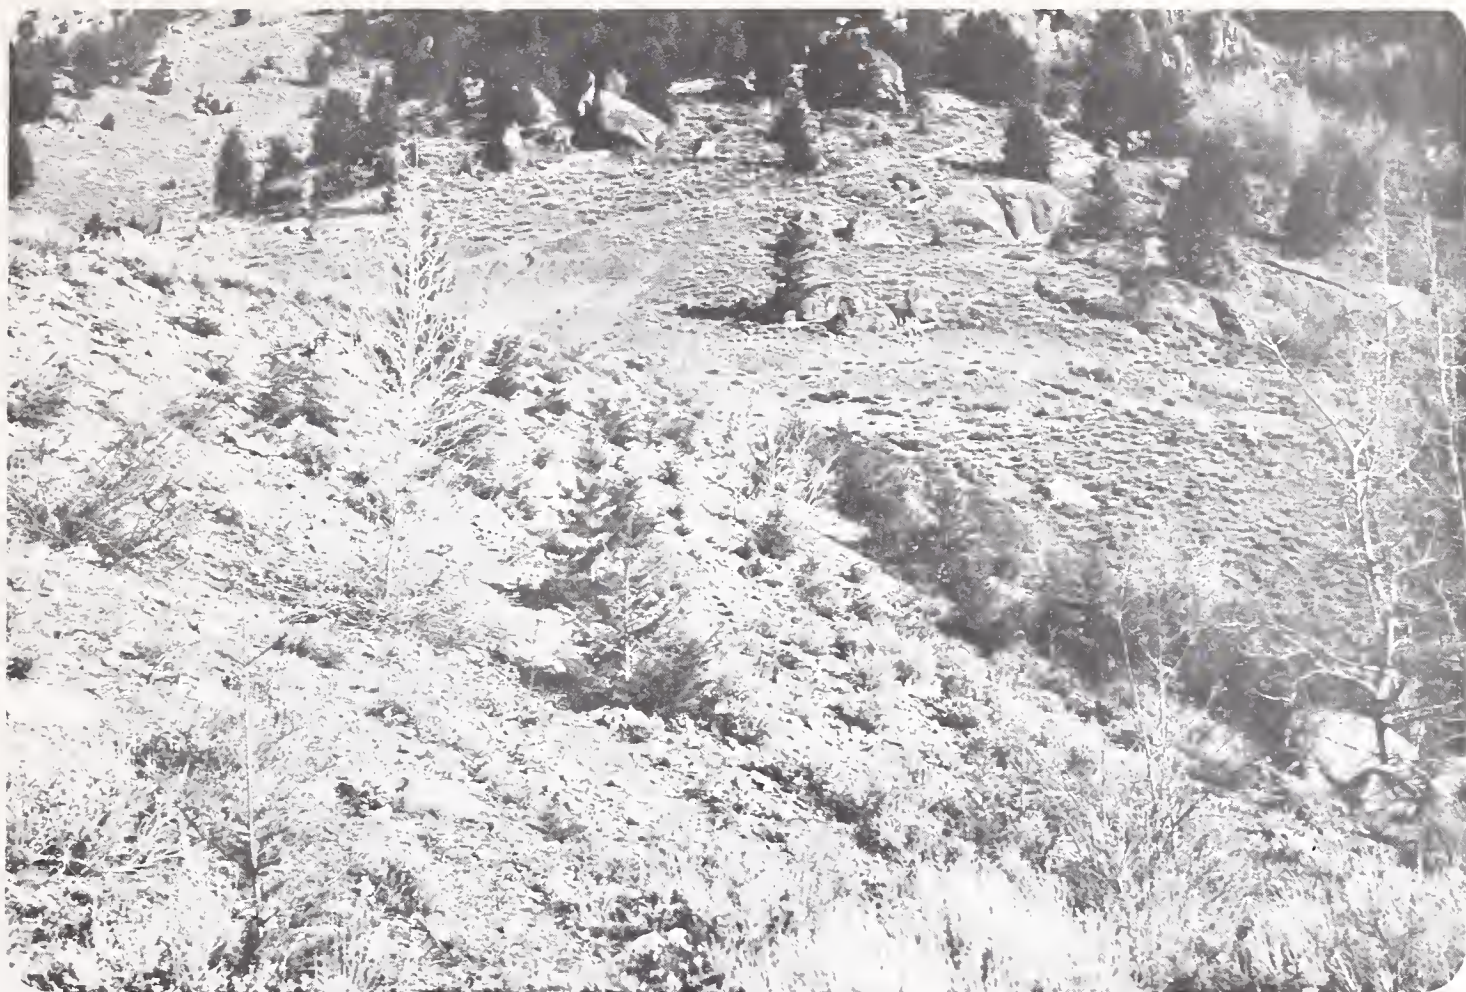
PHOTO 3      Downstream slope and left abutment  
impervious borrow

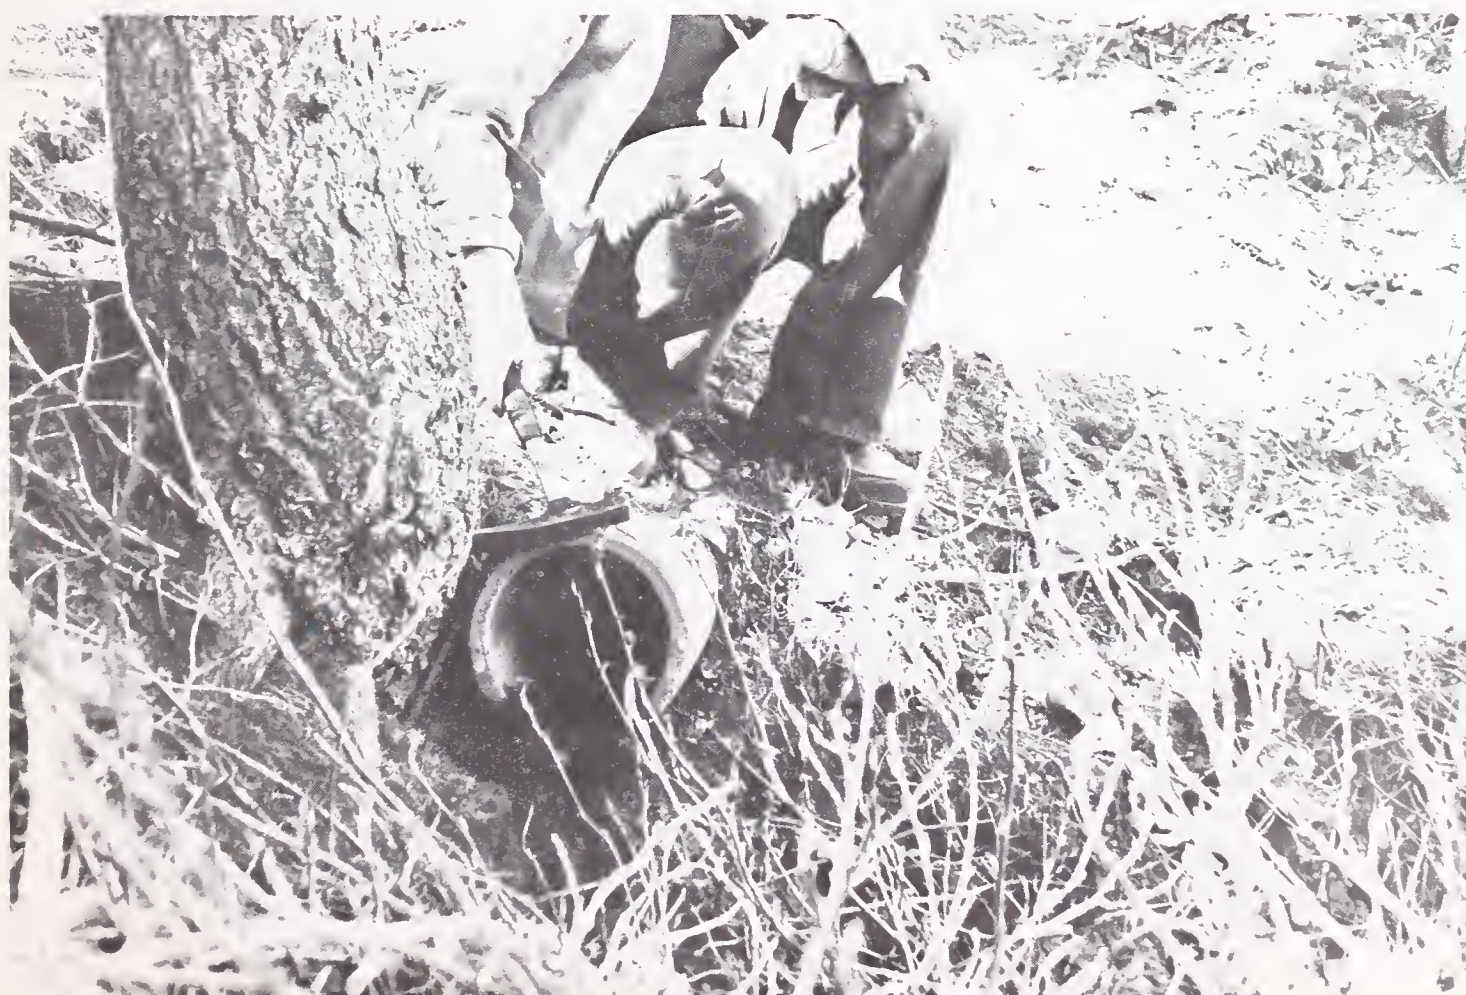
PHOTO 4      Interior drain discharges at right abutment.  
Seepage quantity was only trickle.

4. Monitor erosion damage in the spillway discharge channel to ensure it does not endanger the dam.
5. Determine source of present right abutment seepage and underseepage by installation and observation of piezometers and study of the data. Monitor seepage as related to reservoir levels.

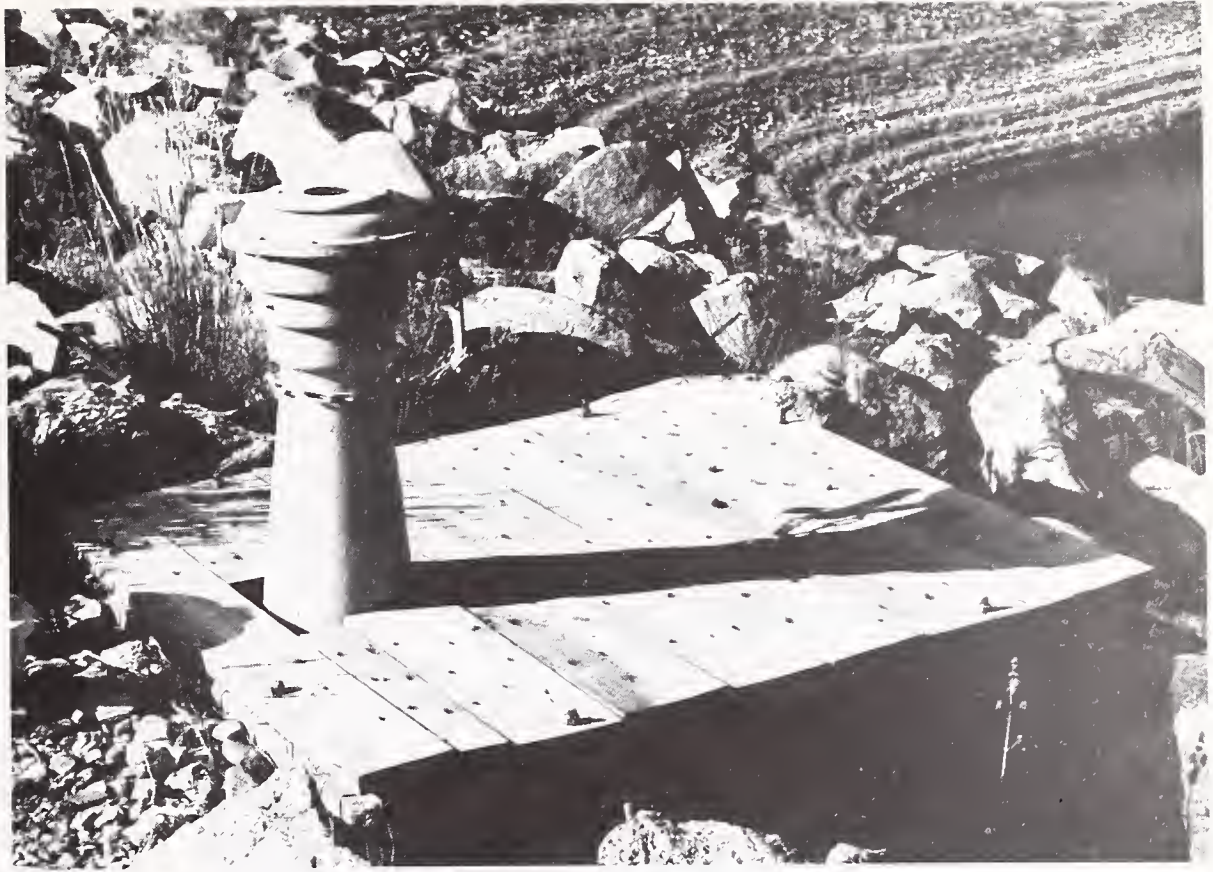
PHOTO 5

The control for the 30-inch-diameter emergency gate valve is located at the bottom of the tower. The control for the 30-inch-diameter operating gate valve is located at the top of the tower near the crest of the dam and appeared to be in good condition (see Photo 5). The control handle is locked to the control housing. A wooden deck on the top of the gate tower is bolted down to prevent easy access to the tower.

Operating gate control at top of  
tower near crest of dam.

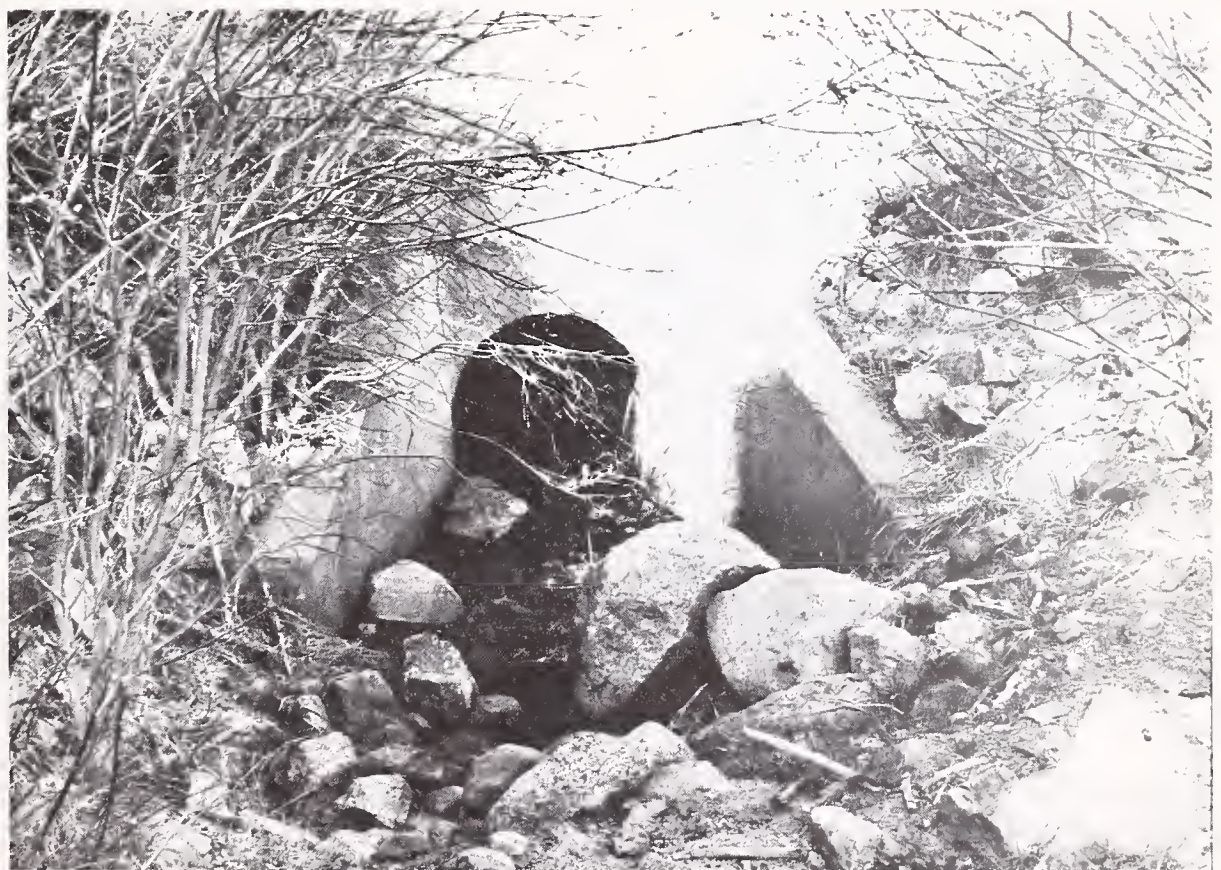
PHOTO 6

The outlet structure at the downstream toe of the dam consists of a pair of divergent wing walls (see Photo 6). The structure was in good condition and only minor erosion was observed downstream. The conduit was not inspected because of its small diameter.

Outlet structure near left abutment.

1. Immediately develop, implement, and periodically test an emergency warning plan for use in the event of impending dam overtopping or structural failure.
2. Remove the few scattered trees, root systems, and brush from the embankment and toe areas. Backfill and compact all depressions.
3. Inspect the low-level outlet conduit and repair it, if required.

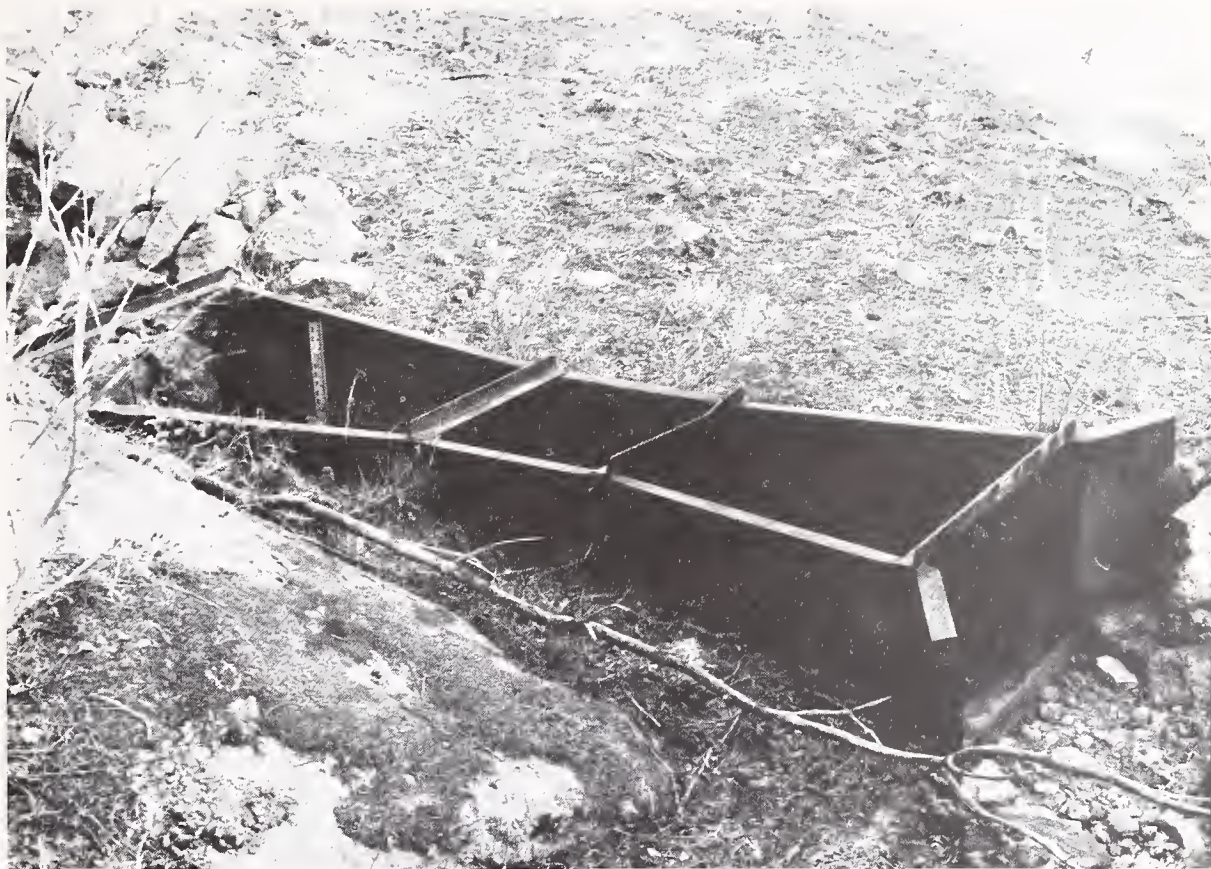
PHOTO 7      Flume downstream of outlet structure.

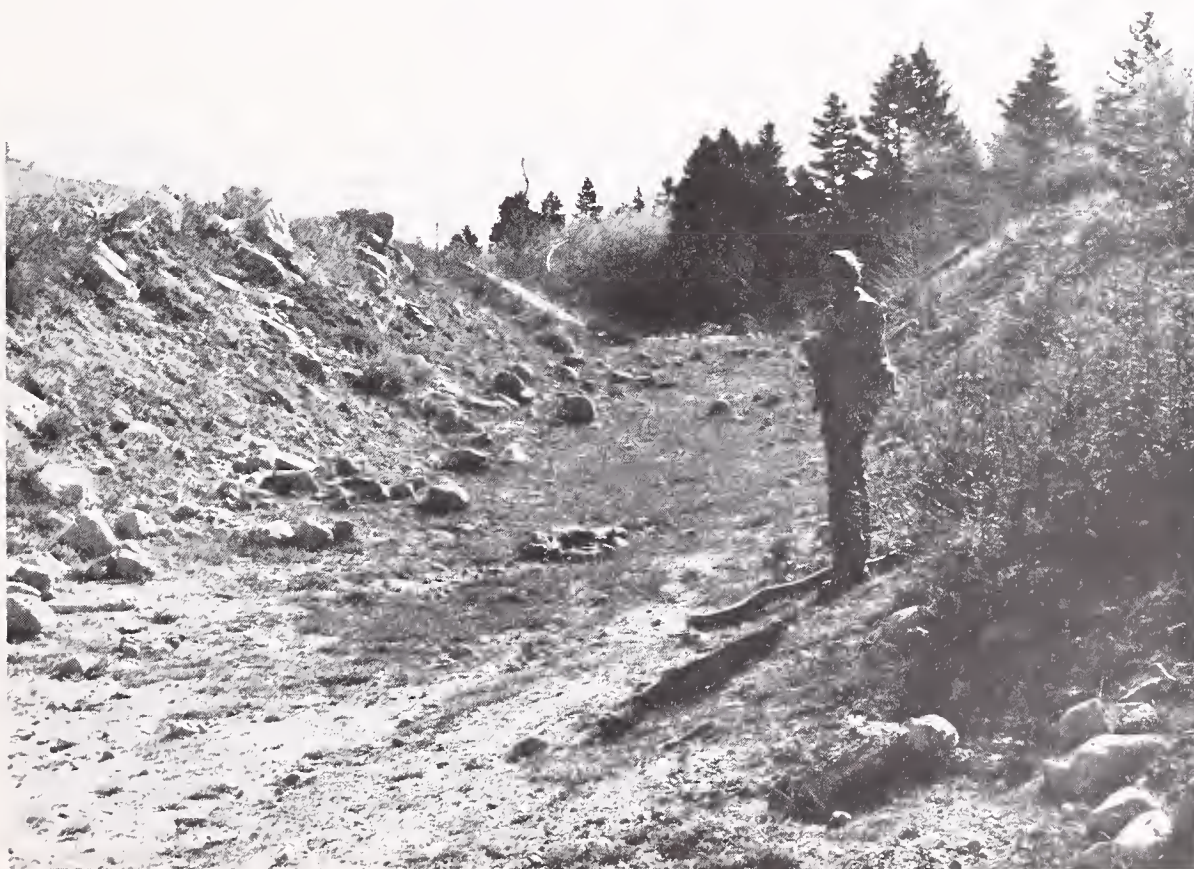
The unlined spillway approach channel (Photo 8) is a trapezoidal section with 1 V (vertical) on 1.5 H (horizontal) side slopes and a bottom width varying from 15 to 18 feet. The channel invert is nearly level. A few rocks (1-foot in diameter) and some small brush are scattered along the length of the channel. No erosion was observed. The spillway has no log boom, but very little debris was observed in the reservoir or along its shore.

PHOTO 8      Spillway approach channel, concrete spillway in background.

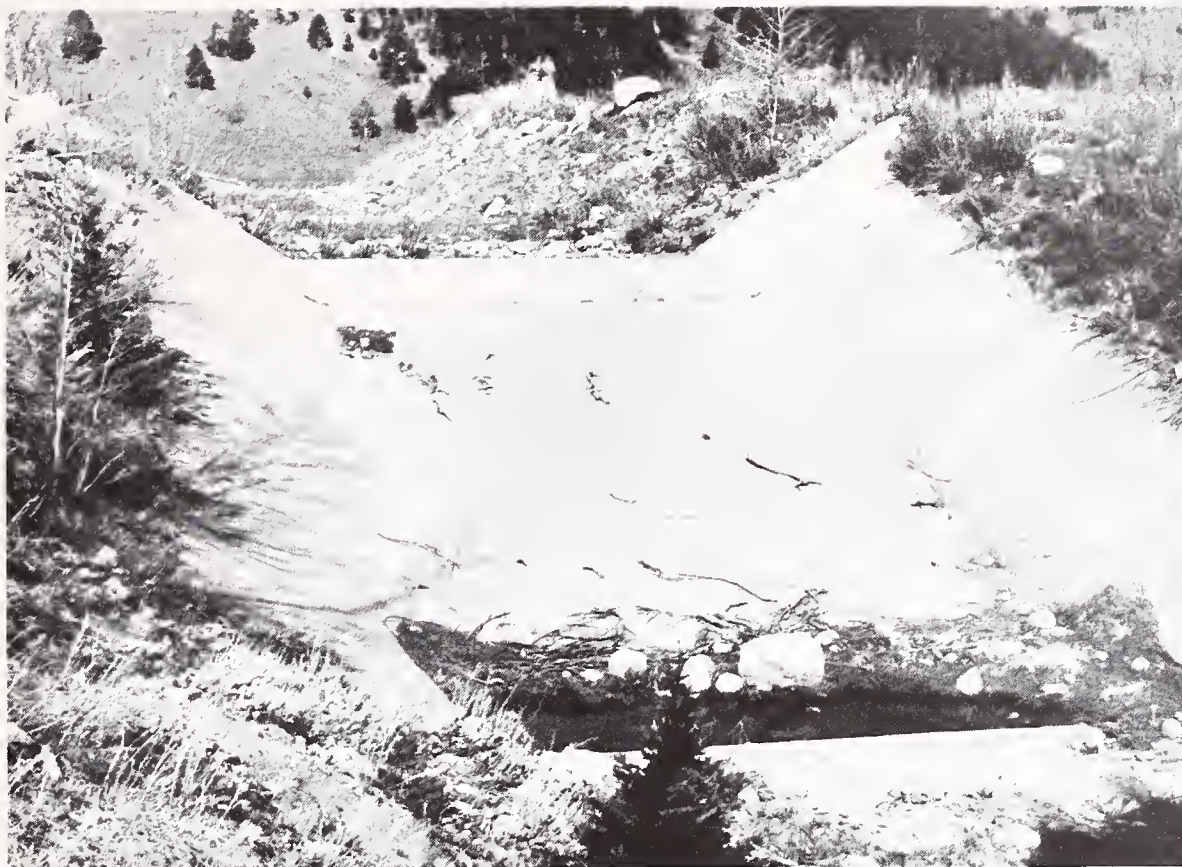
The concrete spillway is a trapezoidal section (Plate 3) with 1 V on 1.5 H side slopes and a bottom width of 20 feet. The crest section is 10 feet in length and is at elevation 6352.4 feet NGVD, approximately 0.6 feet lower than the high point of the approach channel. The crest section connects with a 42-foot-long trapezoidal (1 V on 1.5 H) concrete chute with a bottom slope of 1 V on 4 H. The chute ends at a 6-foot-long trapezoidal (1 V on 1.5 H) concrete stilling basin (Photo 9). All concrete appeared in good condition.

The unlined spillway discharge channel is a trapezoidal section with 1 V on 1.5 H side slopes and a bottom width varying from 15 to 20 feet. Riprap just downstream of the stilling basin does not appear adequate to prevent scouring because of incomplete energy dissipation during high discharges, which is common to trapezoidal stilling basins. No erosion of this area was observed, as the spillway has operated only at low discharges. Approximately 250 feet downstream of the concrete spillway structure, channel erosion from the 1975 spillway discharges was observed. The channel slope upstream from this point is approximately 2 percent, but the channel steepens downstream. The channel ends on the ridge approximately 40 feet higher in elevation

than Cataract Creek. Spillway discharges have caused heavy erosion of the fine material and have left a pile of large rock and fallen trees. The observed spillway erosion is sufficiently removed from the dam and is not serious at this time; however, the erosion requires monitoring.

PHOTO 9      Spillway with water in stilling basin.

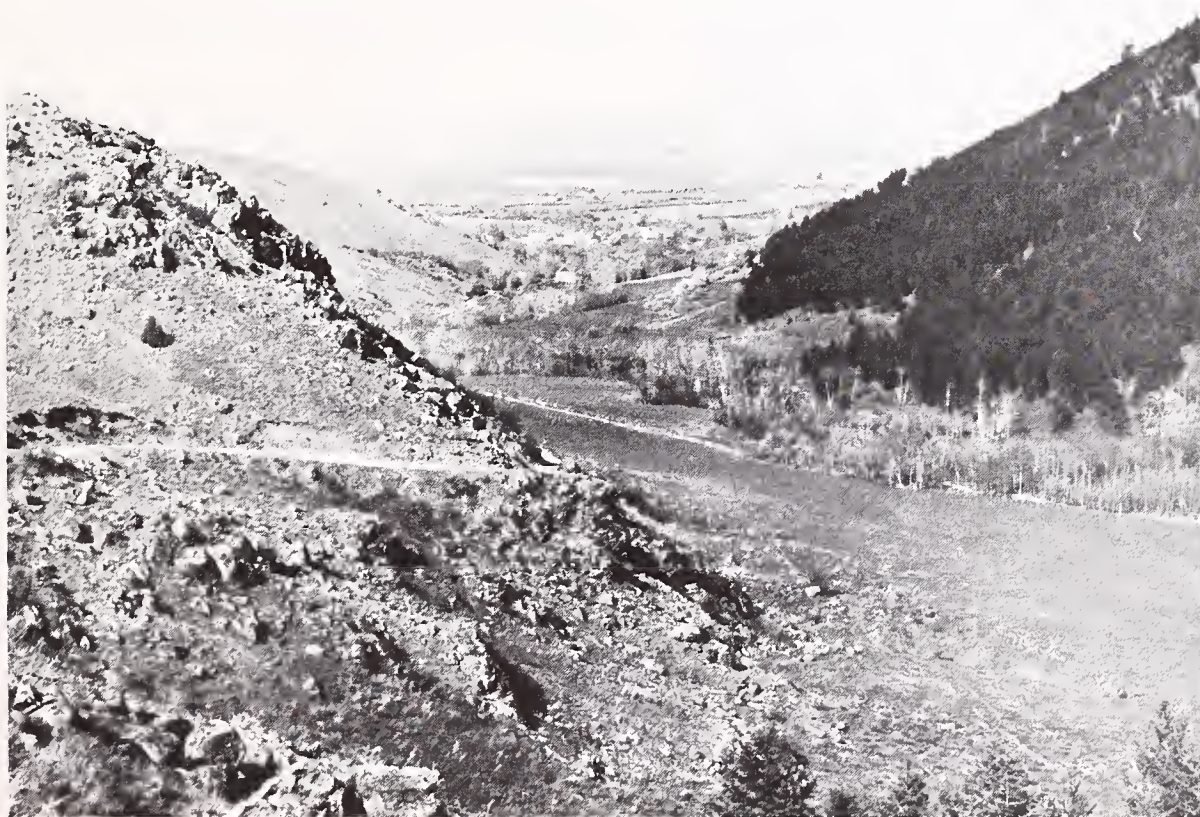
PHOTO 10      View downstream, Town of Pony,  
2 miles distant.
